Manhole Inspection Summary

Manhole # S53K__067MH

Location Address: **rear off 611 S Clinton st**

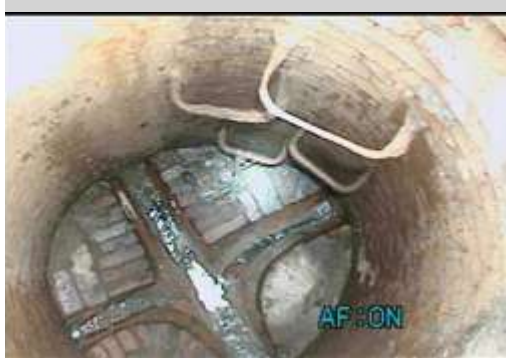
Defect 2

Steps Count: **4** Missing: **0** ☒ **Corroded**

steps

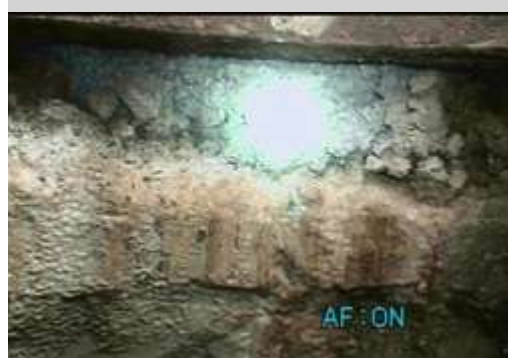
Defect 1

Condition: ☐ Sound ☐ Cracked ☐ Root Intrusion ☒ **Loose Brick** ☒ **Deteriorated**

missing brick, deterioration, frame adjustment
